Tactical Urbanism Results

November 29, 2022

Prepared by the City of Columbus, Department of Public Service

Project Overview

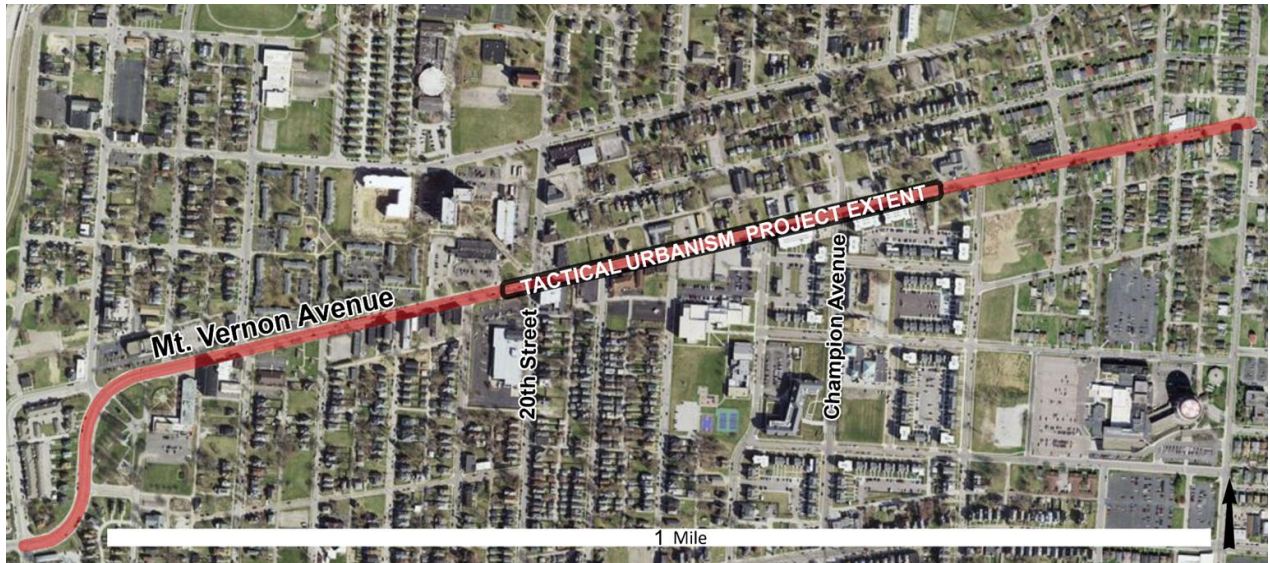
Figure 1. Tactical urbanism project extent

The Department of Public Service placed an interim safety treatment on Mt. Vernon Avenue from 20th Street to Phillips Street in September 2021 (see Figure 1).

This treatment includes the following:

- All-way STOP signs at Champion Avenue and Mt. Vernon Avenue
- All-way STOP signs at Ohio Avenue and Mt. Vernon Avenue
- Type II (ladder-style) crosswalks at 22nd Street (near Champion Middle School) and Champion Avenue
- Striped parking lanes with curb extensions delineated with flex posts along Mt. Vernon Avenue

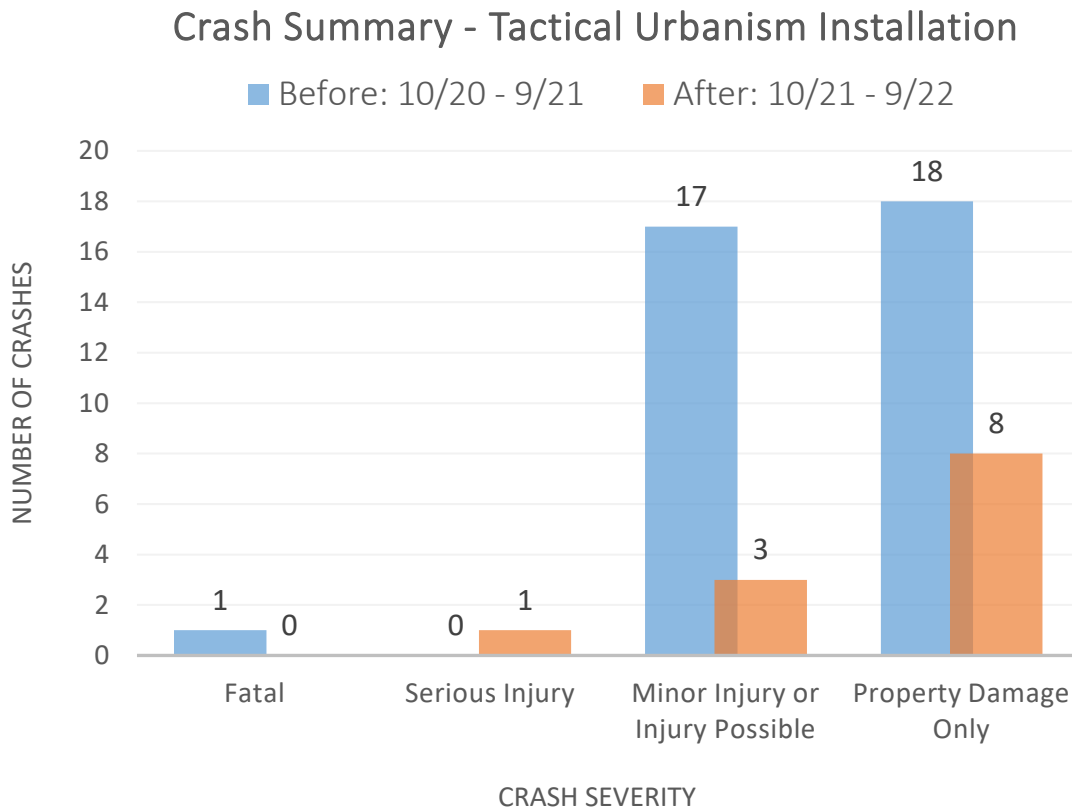
Figure 3. Number of crashes by severity before and after tactical urbanism

A total of 36 crashes occurred on Mt. Vernon Avenue prior to the tactical urbanism installation, from October 2020 to September 2021 (Figure 2). There were 13 minor injury crashes, four possible injury crashes, and 18 property damage only crashes on the corridor from October 2020 through September 2021 (Figure 3). The most common crash type was angle, accounting for nearly 70% of all crashes. Alcohol and drugs were not considered factors in all of these crashes. Four crashes were considered speed-related. Half of all crashes occurred at a four-way intersection.

The number and severity of crashes were reduced significantly after the tactical urbanism installation. Comparing crashes before and after installation shows that **crashes were reduced by approximately 65% and fatal/injury crashes were reduced by roughly 83%**. The changes persist over time, with the after period showing a significant reduction of crashes.

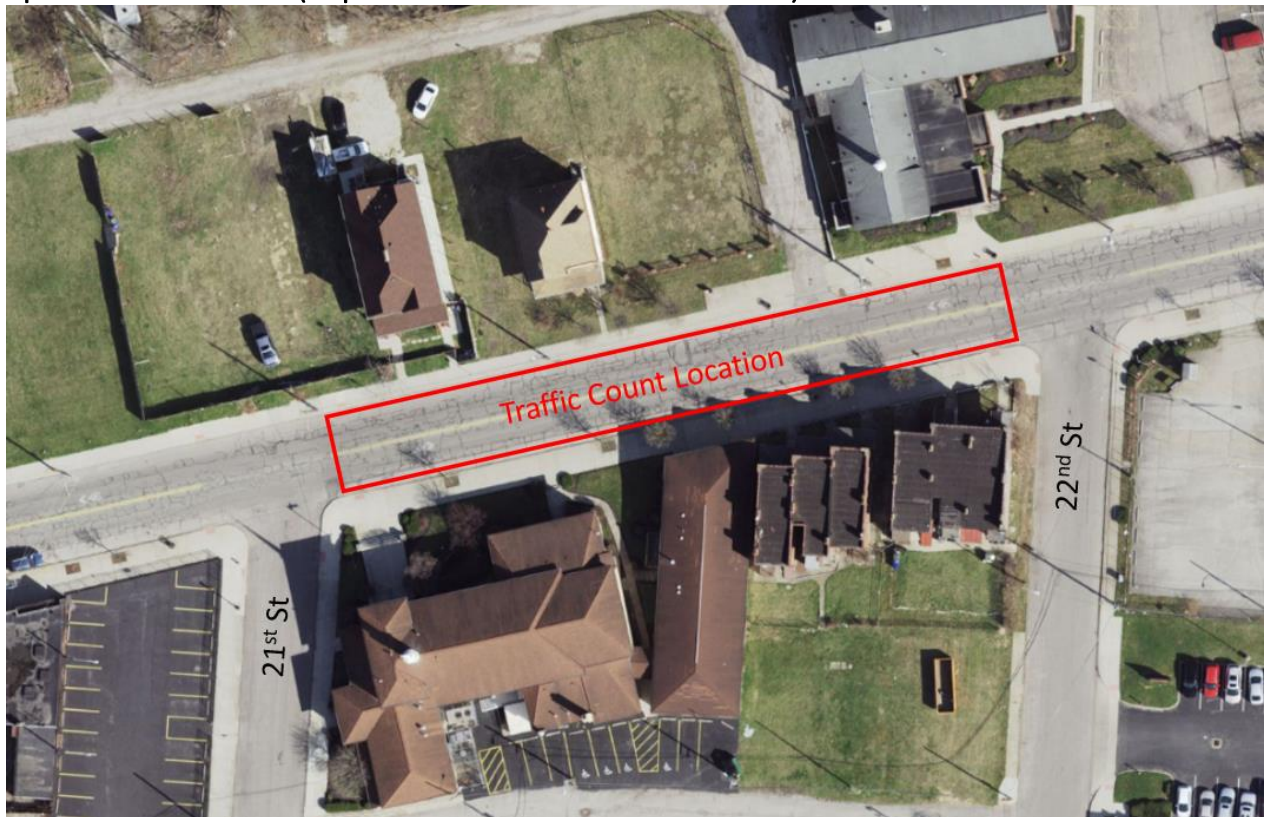
Figure 5. Approximate location of traffic counts collected between 21st and 22nd

Speed data were collected before and after the installation, with counts in September 2021, March 2022, and October 2022. Traffic counts were collected at two locations, the western end of the tactical urbanism installation between 21st St and 22nd St (Figure 5) and at the eastern end of the installation between Champion Ave and Phillips St (Figure 6). Average speeds were reduced by approximately 0-2 MPH. 85th percentile speeds (the speed at which 85% of vehicles are traveling at or below) were reduced by roughly 2-4 MPH. The results of the counts for the east and westbound lanes for each location are depicted in figures 7 and 8.

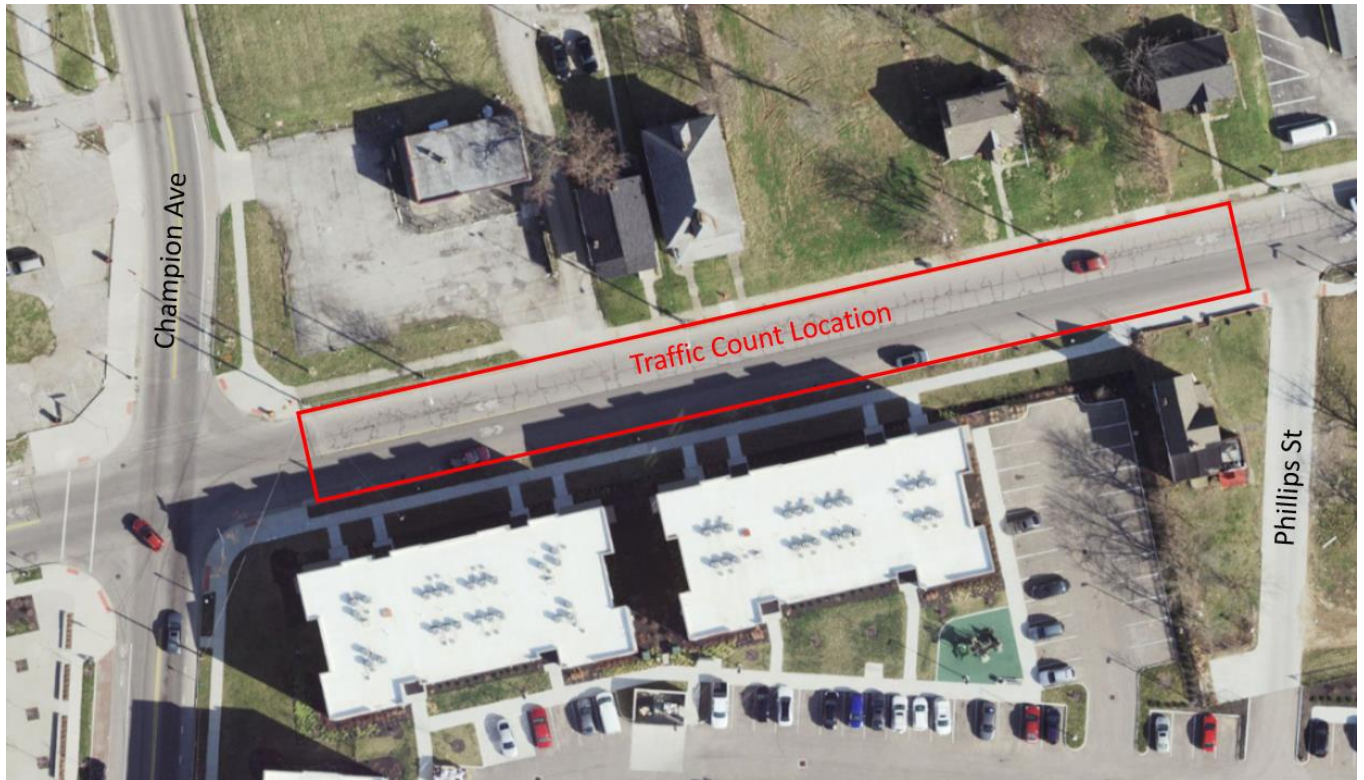
Figure 6. Approximate location of traffic counts collected between Champion and Phillips

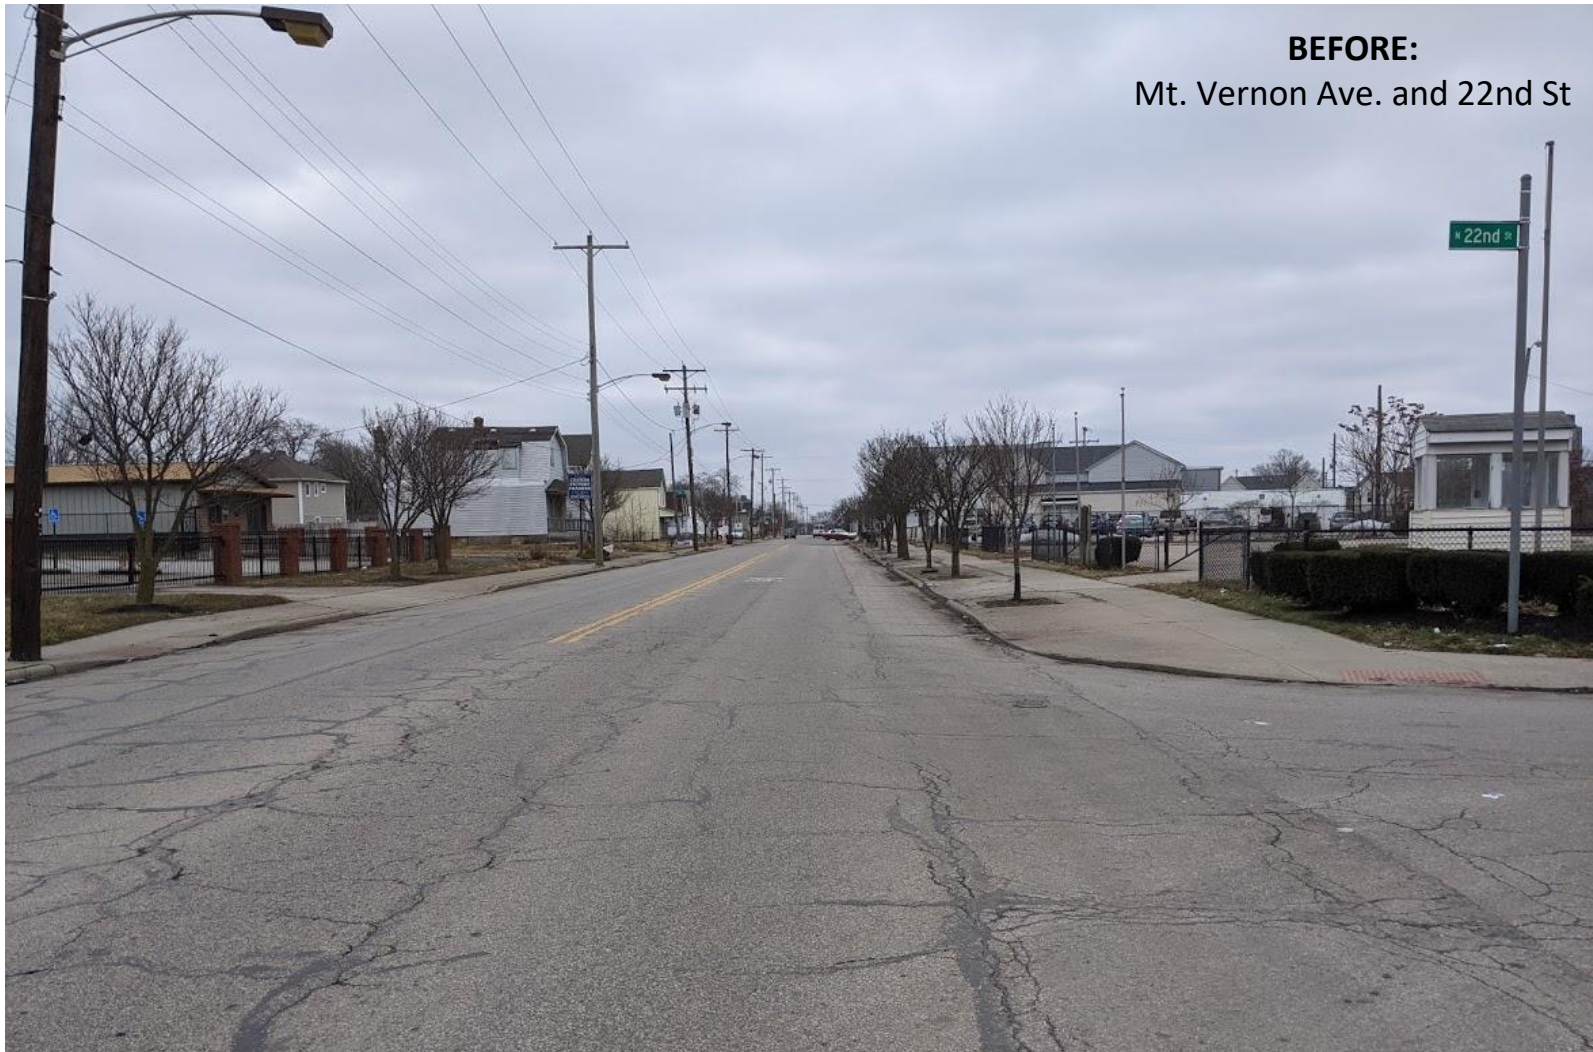
BEFORE:
Mt. Vernon Ave. and 22nd St

Figure 9. Photo of Mt. Vernon and 22nd before tactical urbanism

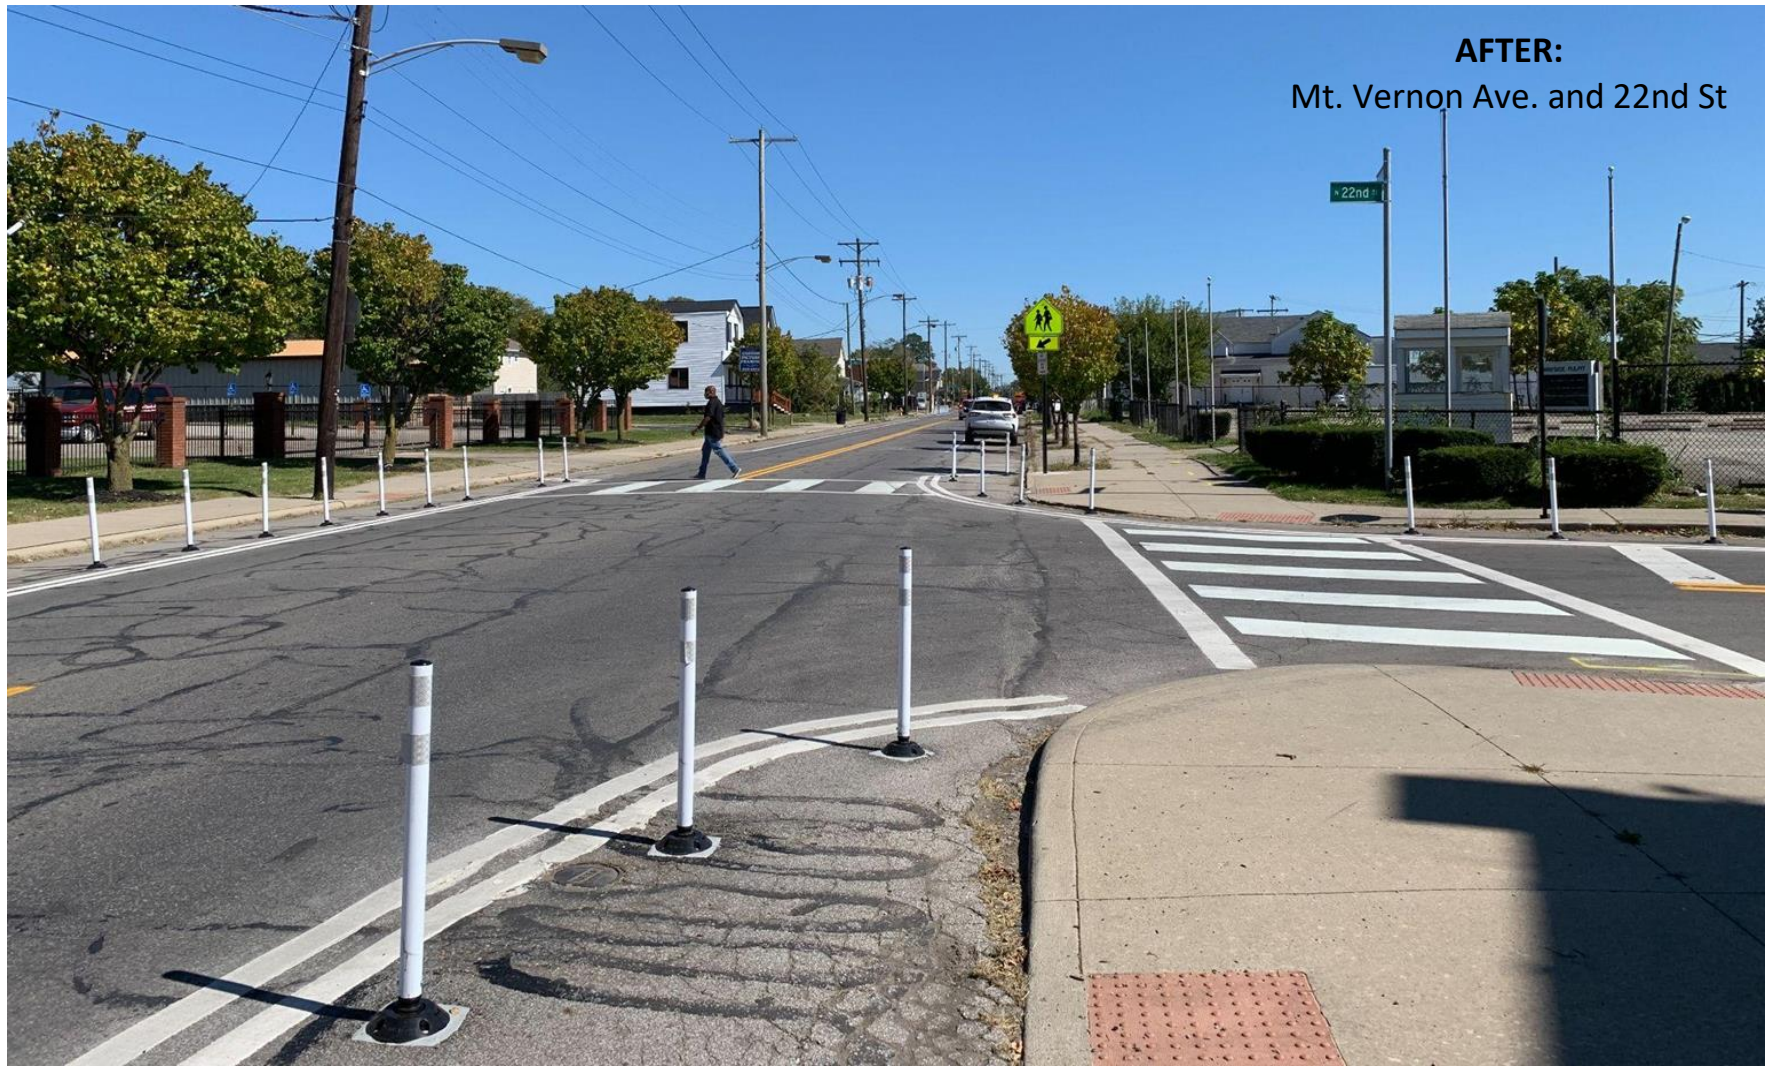
AFTER:
Mt. Vernon Ave. and 22nd St

Figure 10. Photo of Mt. Vernon and 22nd after tactical urbanism

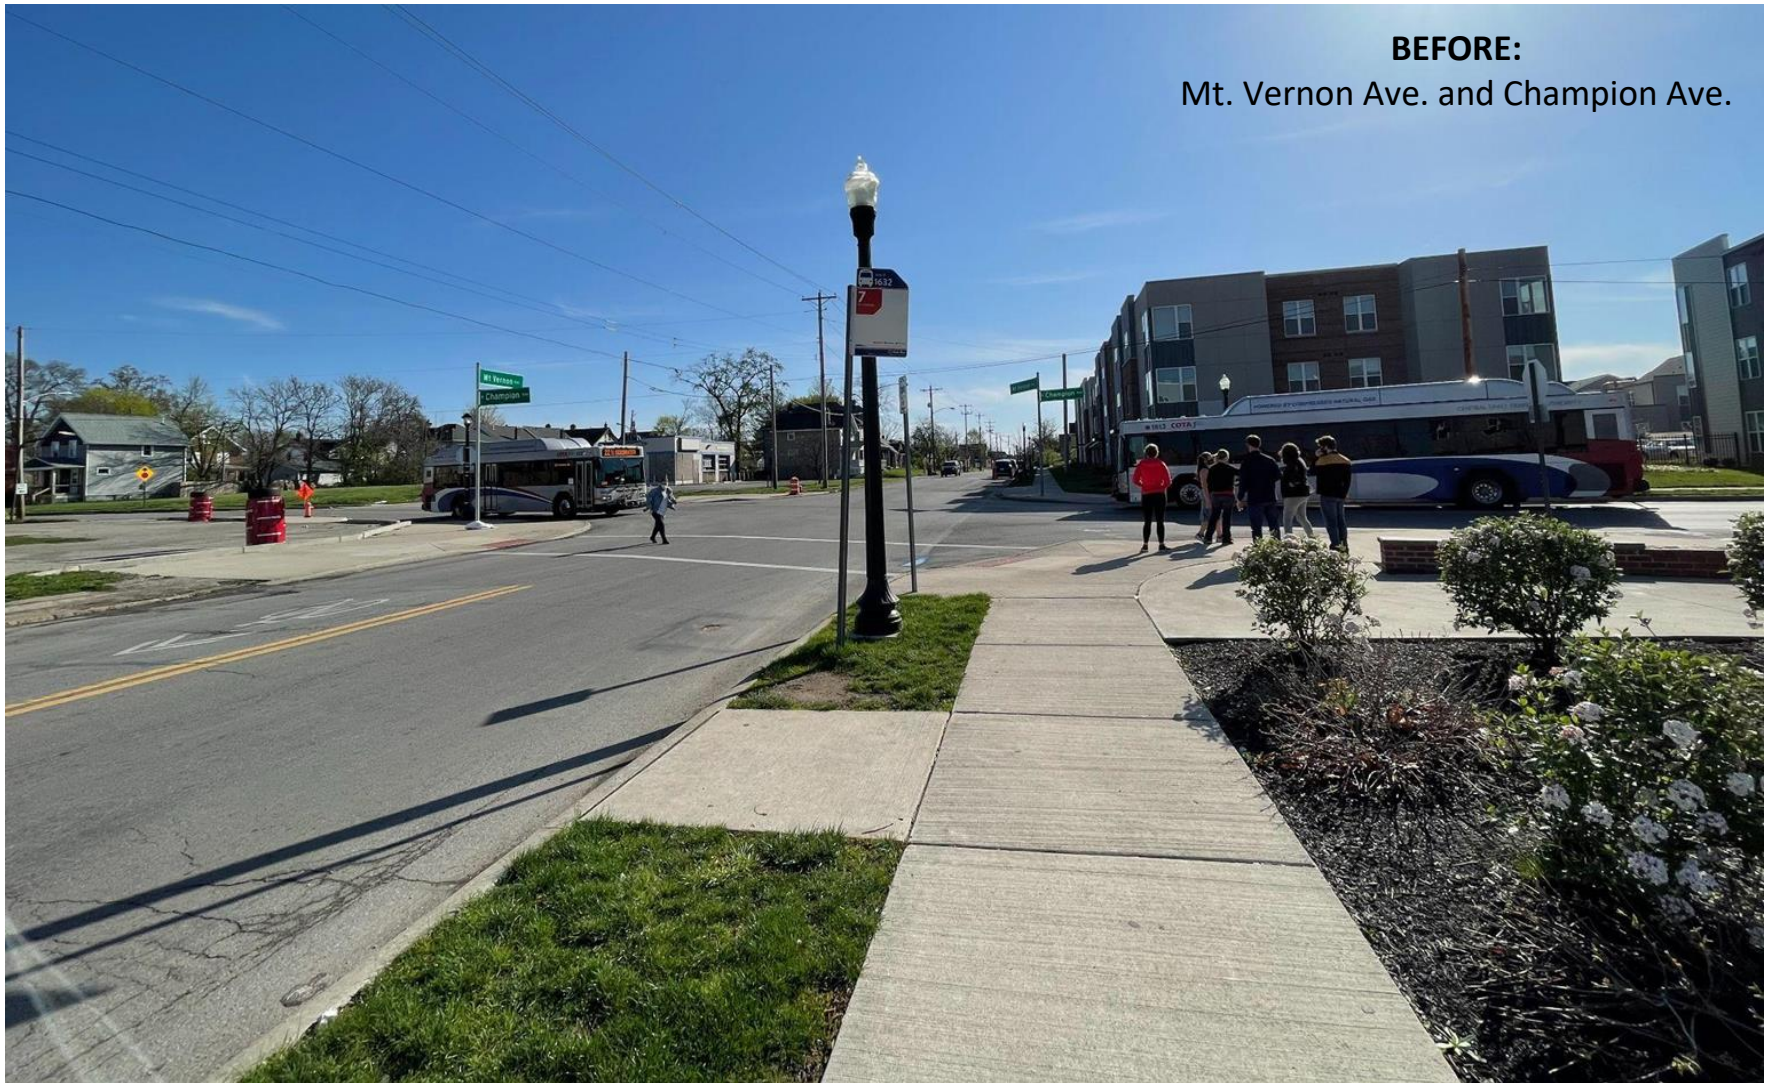
Figure 11. Photo of Mt. Vernon and Champion before tactical urbanism

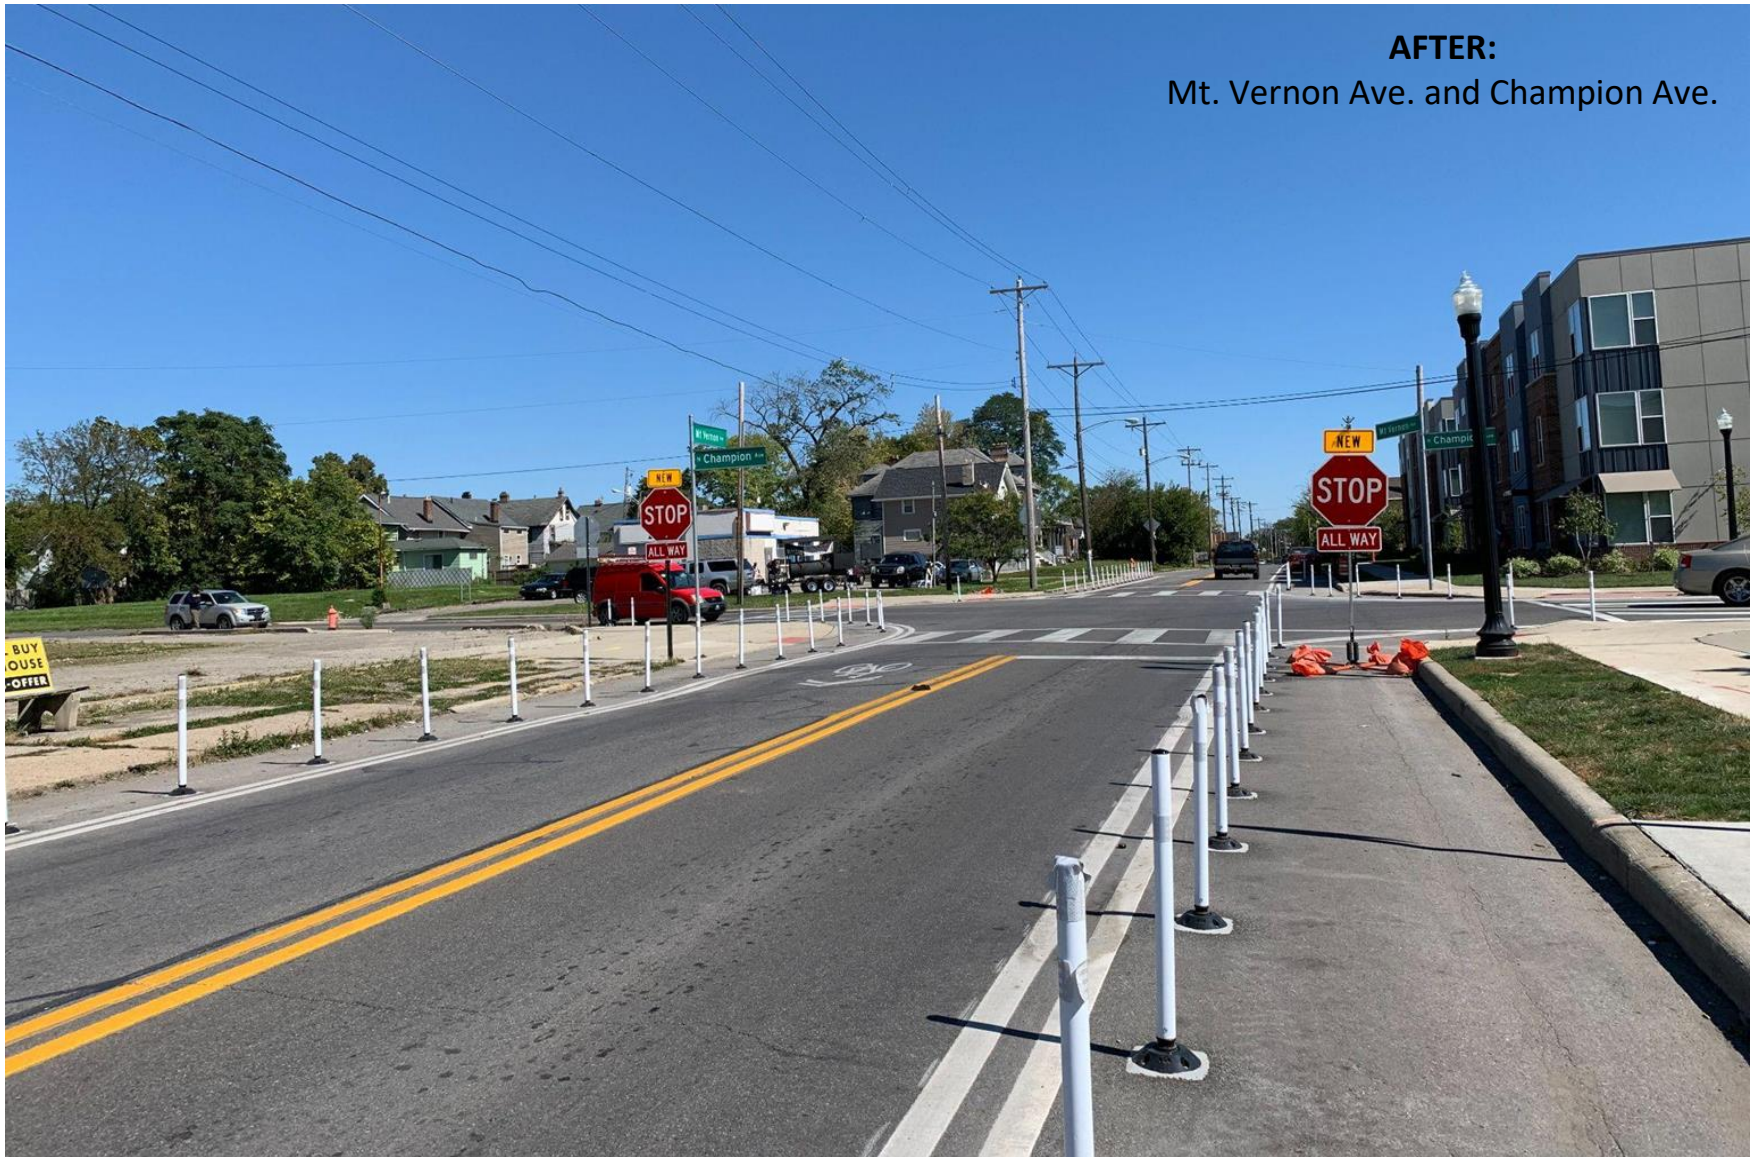
AFTER:
Mt. Vernon Ave. and Champion Ave.

Figure 12. Photo of Mt. Vernon and Champion after tactical urbanism

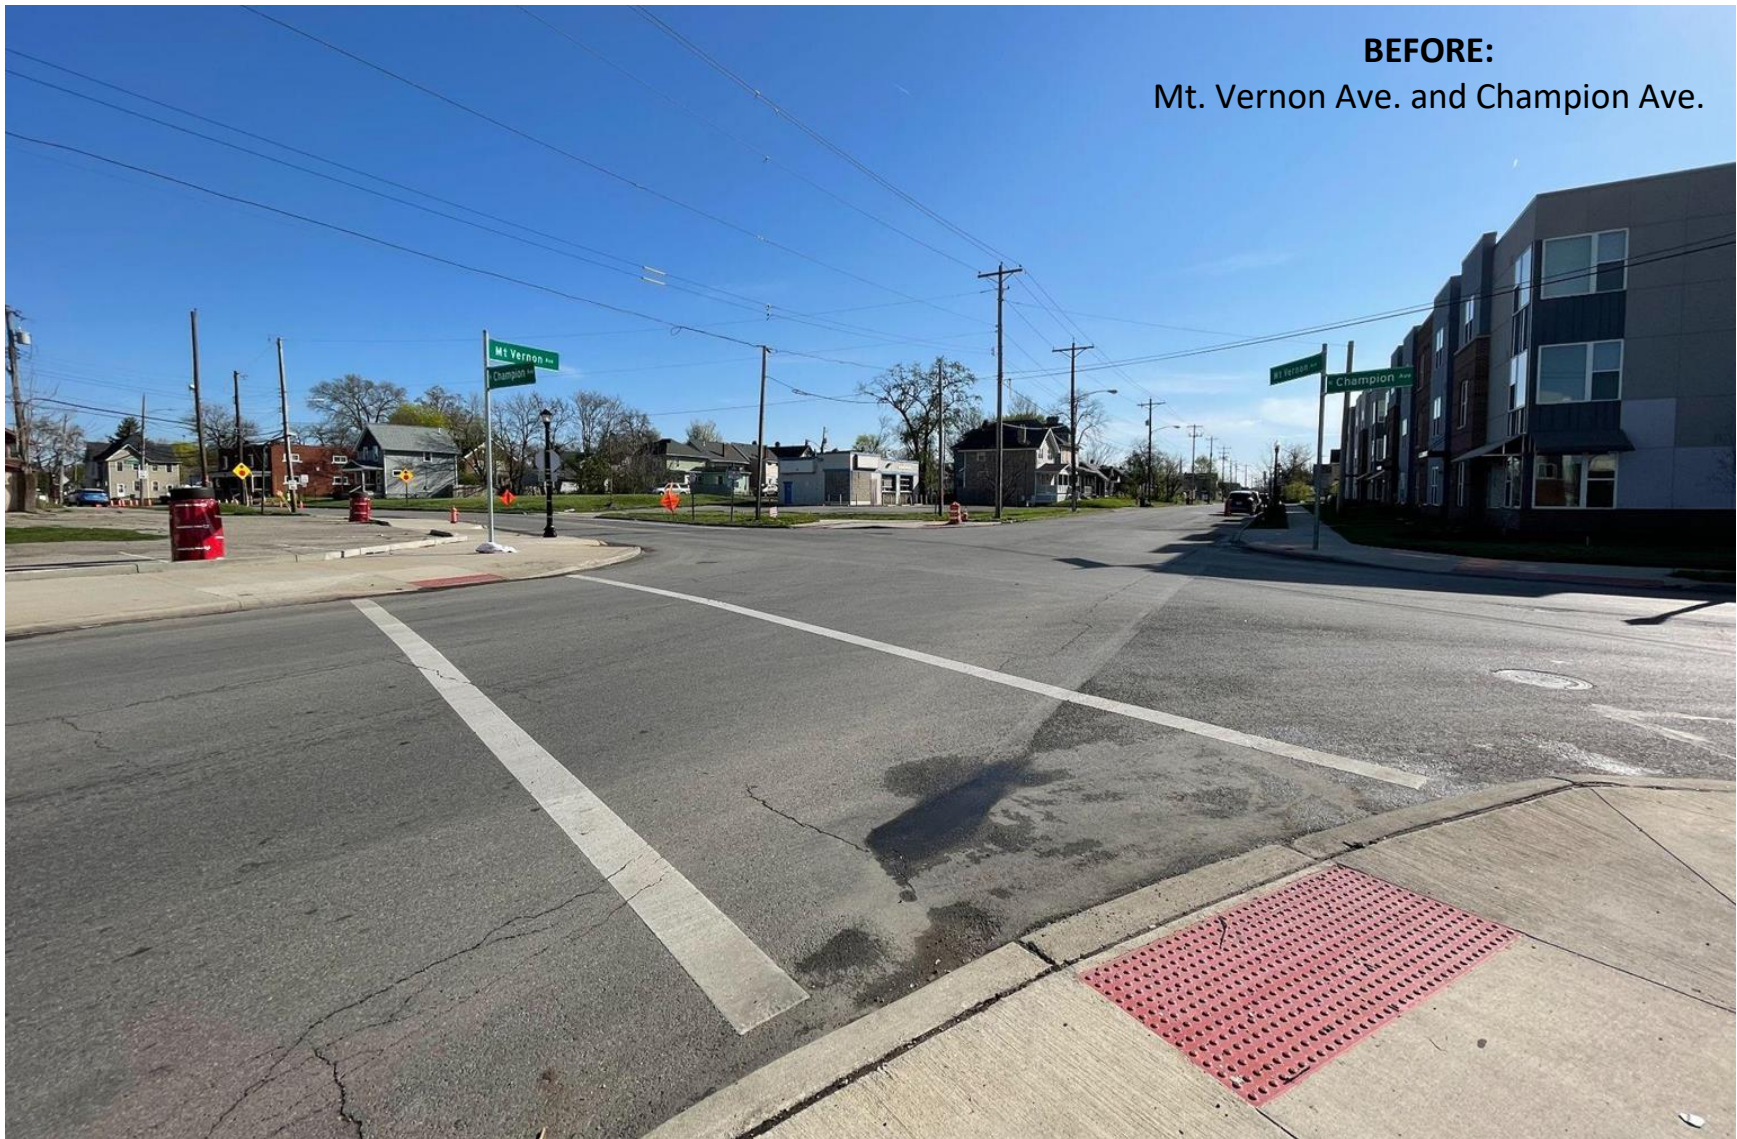
Figure 13. Photo of Mt. Vernon and Champion before tactical urbanism

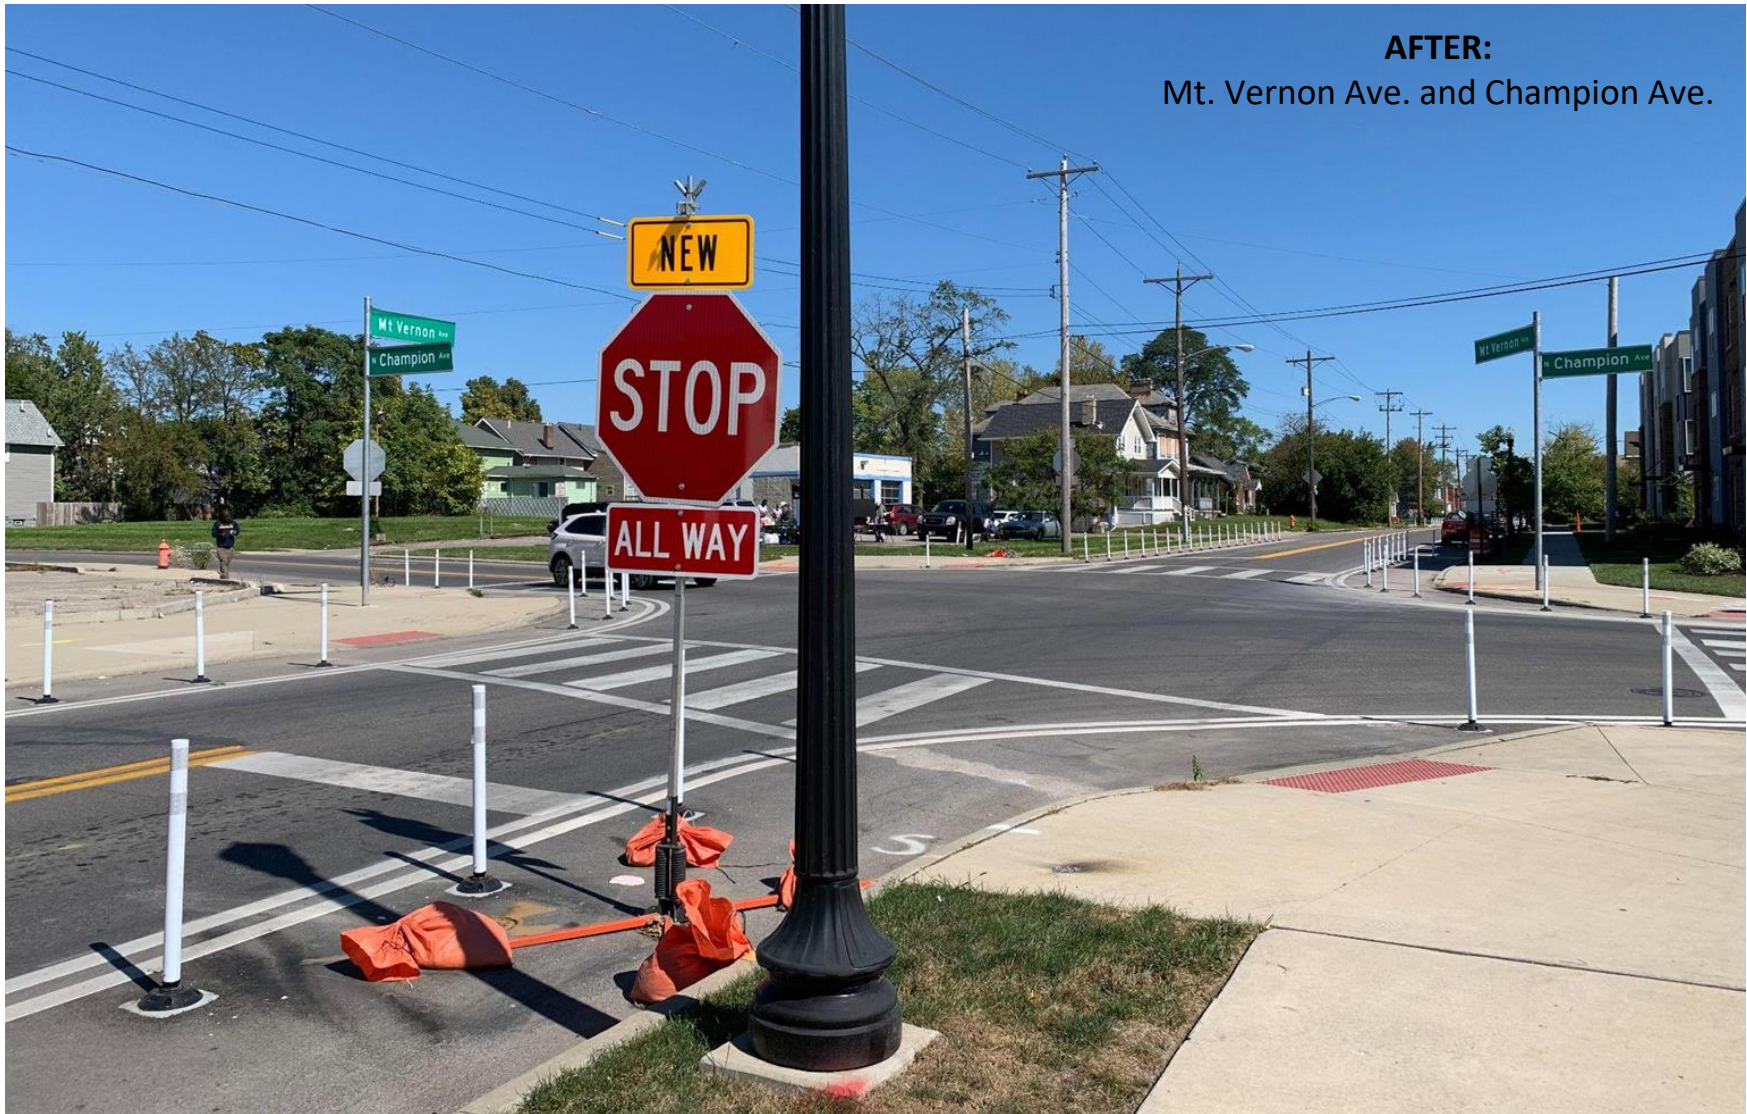
AFTER:
Mt. Vernon Ave. and Champion Ave.

Figure 14. Photo of Mt. Vernon and Champion after tactical urbanism
